**URBAN WATERSHED  
RIPARIAN AREA HEALTH ASSESSMENT**

*Ellen's Creek*

*Wright's Creek*

January 2013

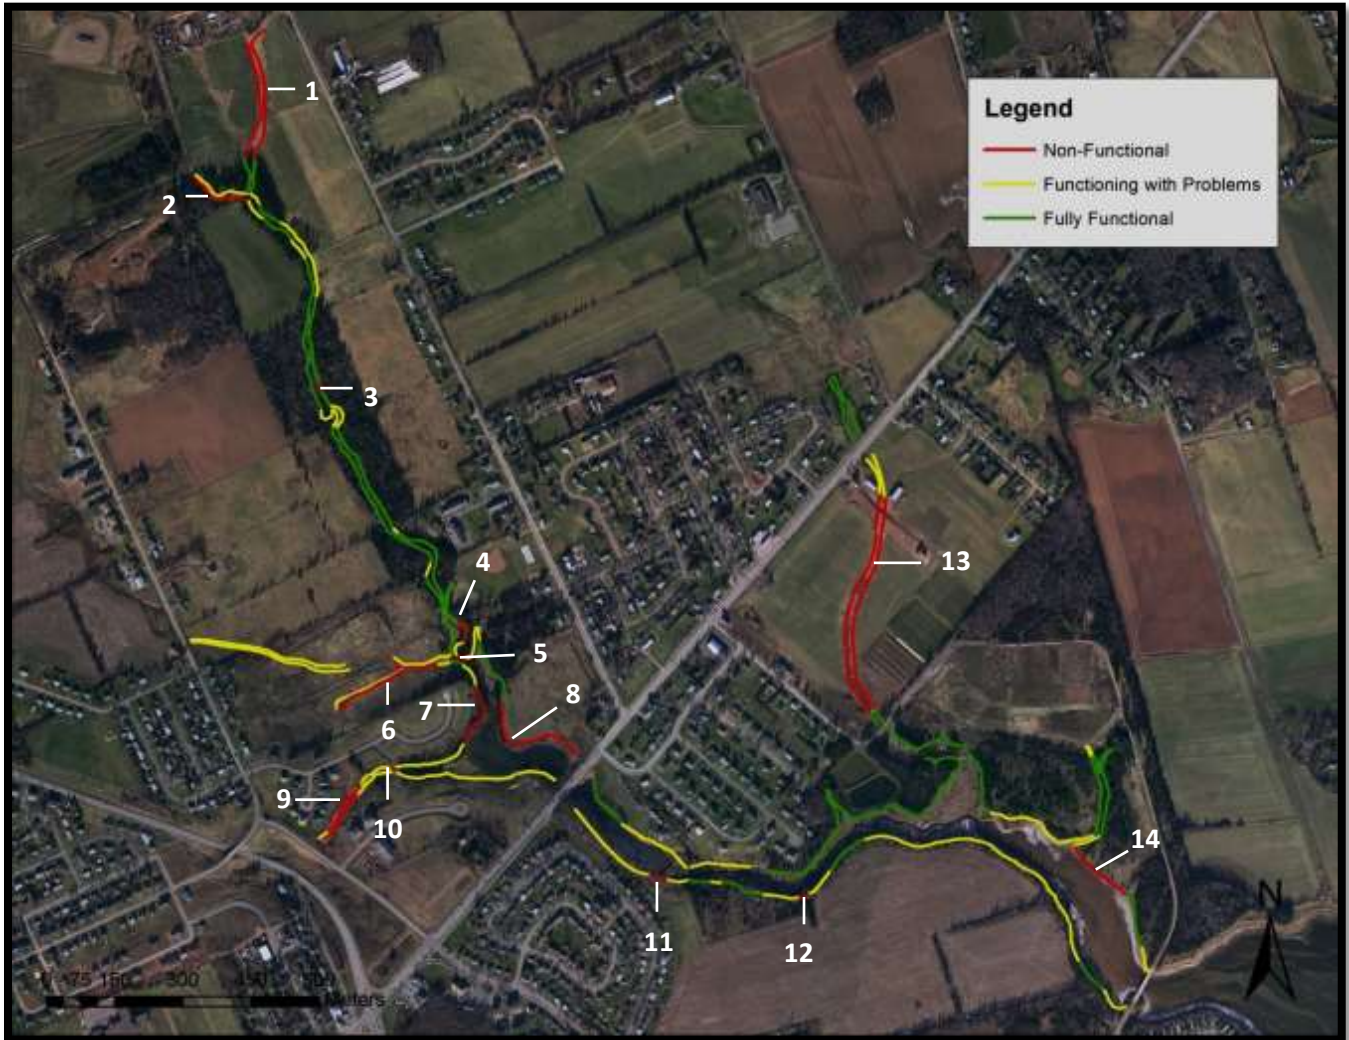
Figure 2. A map of Wright's Creek showing the degree of riparian area functionality.

Upon completion of the Riparian Area Health Assessment on Wright's Creek, a large portion of the riparian area was found to be functioning at a high or acceptable level. These numbers are correlated with the significant amount of woodland found along the watercourses. The northernmost branch of the stream flows through mixed coniferous/deciduous woods. In some sections, large Eastern Hemlock (*Tsuga canadensis*) and Yellow Birch (*Betula alleghaniensis*) grow along the stream banks. These species are indicative of remnant Acadian forest, which is rare to see within city limits. Several springs feed into the stream along this branch, which consistently scored above 80% (green), signifying optimal functionality in

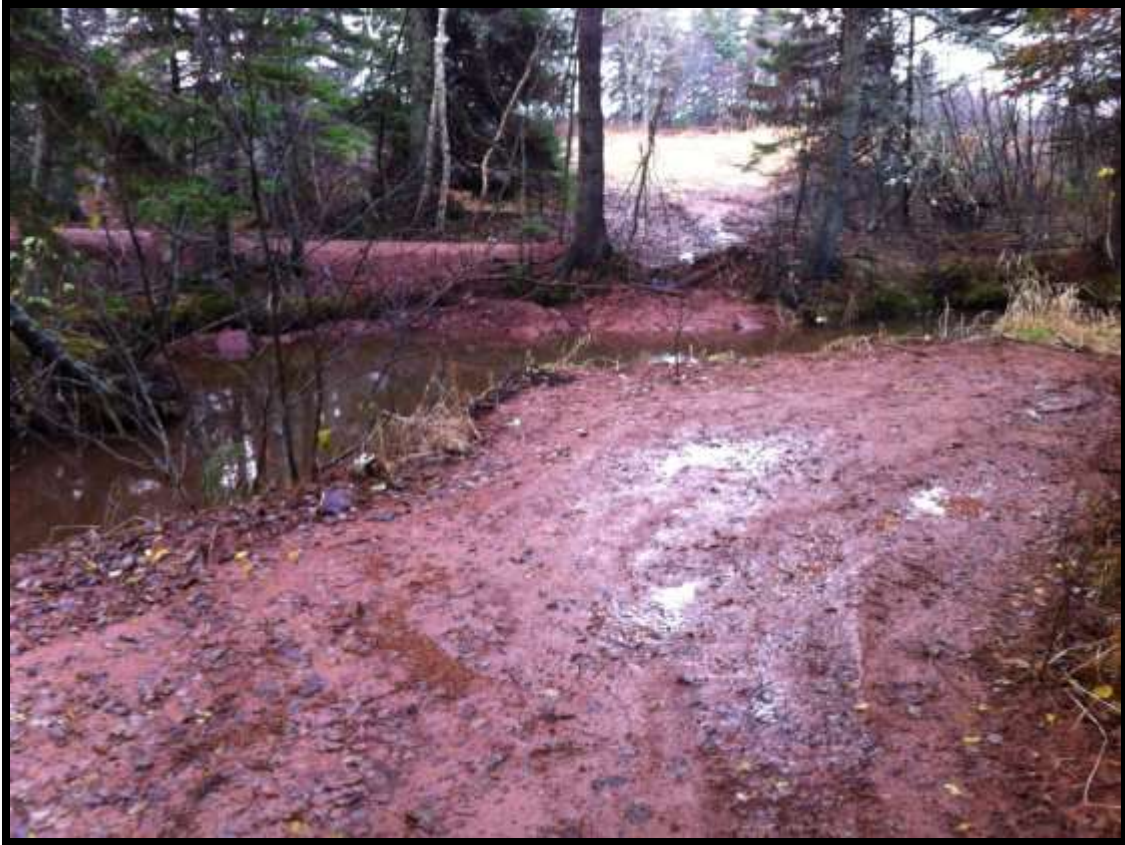
- 5- Red zone 5 is a short distance downstream from red zone 4, and exhibits the same riparian characteristics. It appears this area has been cleared during the recent stream alterations, exposing a large area of bare ground. Again, this exposed earth has no vegetation to help reduce sediment from entering the stream during rainfall. The stream flows faster here, and a high water event could cause substantial erosion of the stream banks. The riparian area is very dysfunctional, and the risk of damage to the stream is high. Heavy planting of trees and shrubs, and soil protection in the form of grass or mulch would be beneficial to this zone. For more immediate protection, hay bales, and silt fencing along the stream could be appropriate treatments.

**Figure 3. A photo of red zone 5, a non-functional riparian area.**

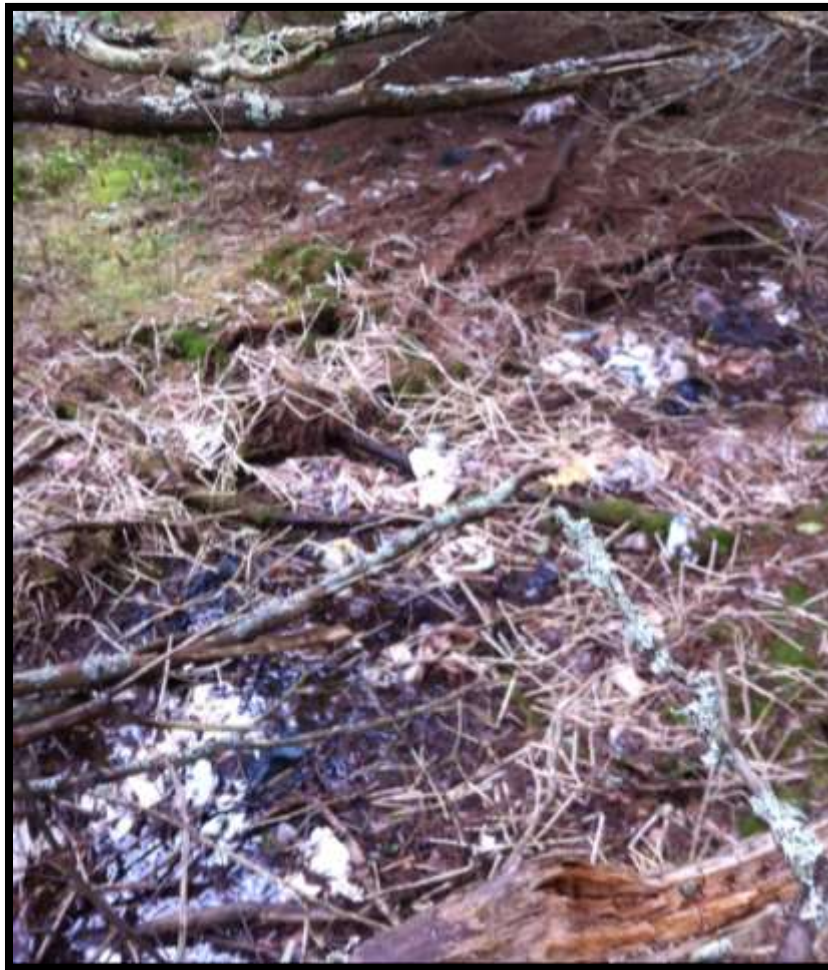
high quality water to the main branch. Further upstream, smaller springs also feed into the creek. Although siltation is a problem along most of Wright's Creek, this northern branch contains stretches where small stones and cobble line the stream bed. This provides suitable spawning locations for fish. Stream enhancement techniques aimed at controlling silt levels are improving spawning habitat. Such improvements to this branch, along with the recent restoration of Andrew's pond will create desirable conditions for fish, and other aquatic life. To the south of St. Peters Road, a small branch feeds the salt marsh from the east. It flows from the old landfill site near Robertson Road. A large amount of garbage, presumably remnants of the landfill, covers the streambed to the point of obstructing water flow. Although this tributary is very small, and volume of water is minimal, the excessive amount of garbage is concerning.

**Figure 5. A photo of garbage along the stream bed near the old dump site.**

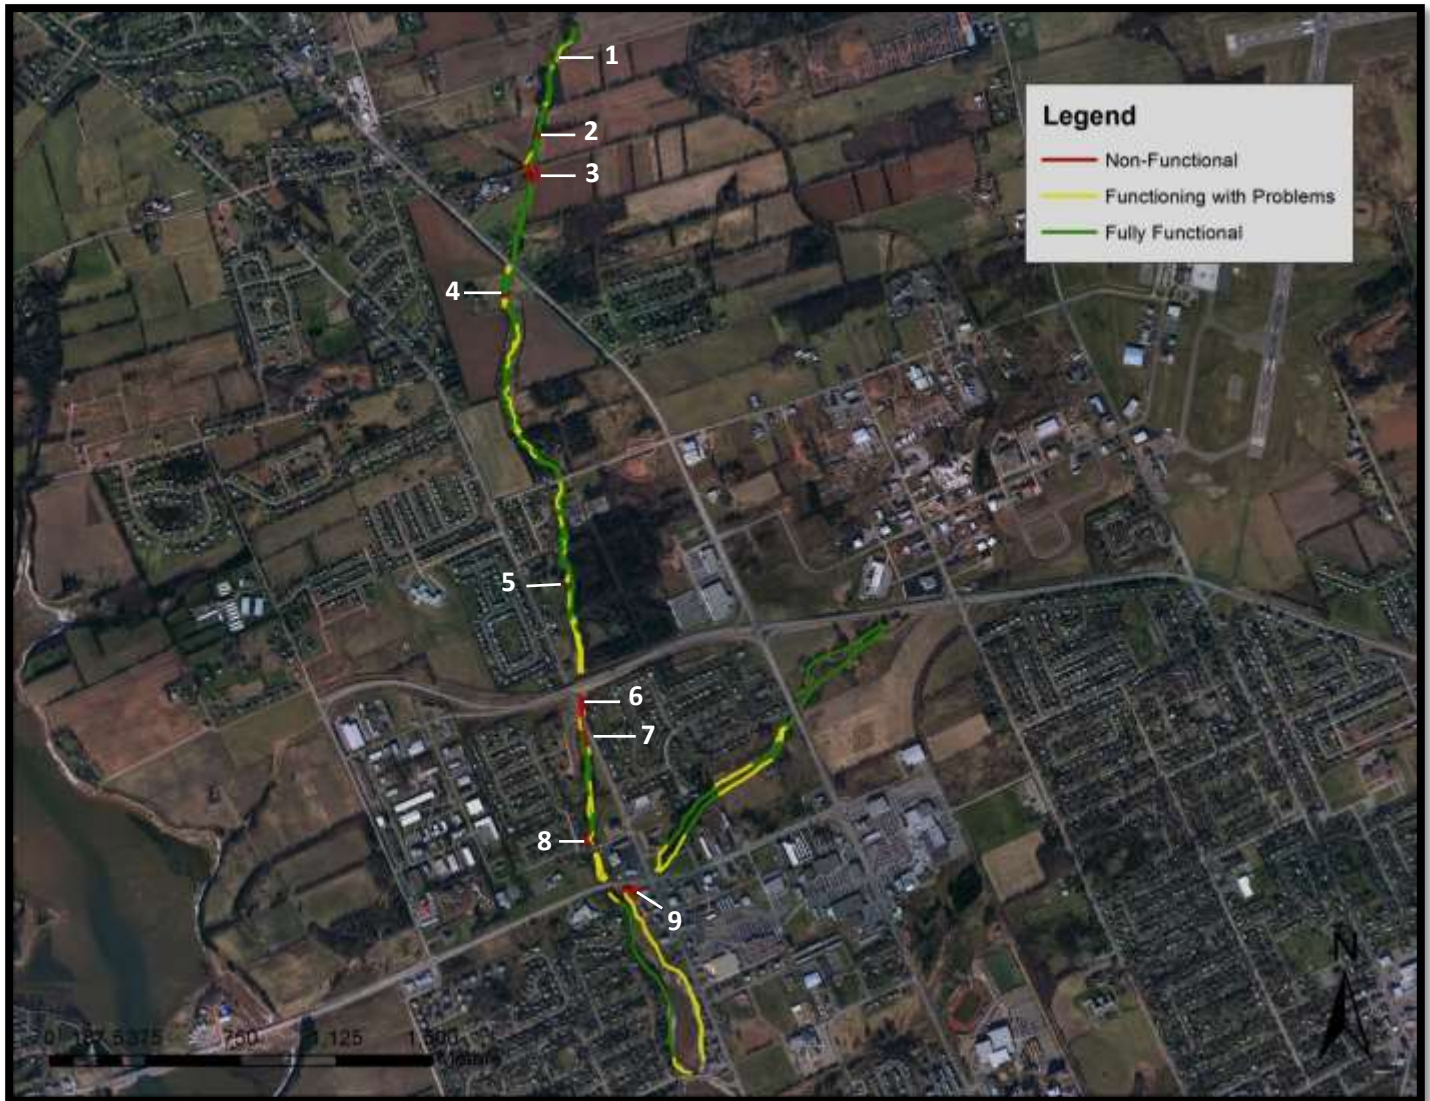
**Figure 7. A map of Ellen's Creek displaying various degrees of riparian functionality**

The results of the Riparian Area Health Assessment on Ellen's Creek show the majority of the riparian area to be functioning at an acceptable level. However, several 'red' areas were discovered. These non-functional zones are relatively small in length, but require action to prevent damage to the waterway. Some of the 'yellow' stretches along Ellen's Creek may also be treated as high risk due to their proximity to major commercial and residential development. This intensifies the risks to riparian functionality, and may require special attention in regards to upland management. In particular, the 'yellow' stretch on the east of the salt marsh may be considered high risk. The assessment results show the healthiest stretch of
